# A Guide for Analyzing the Muon Monitor Signals

(not comprehensive)

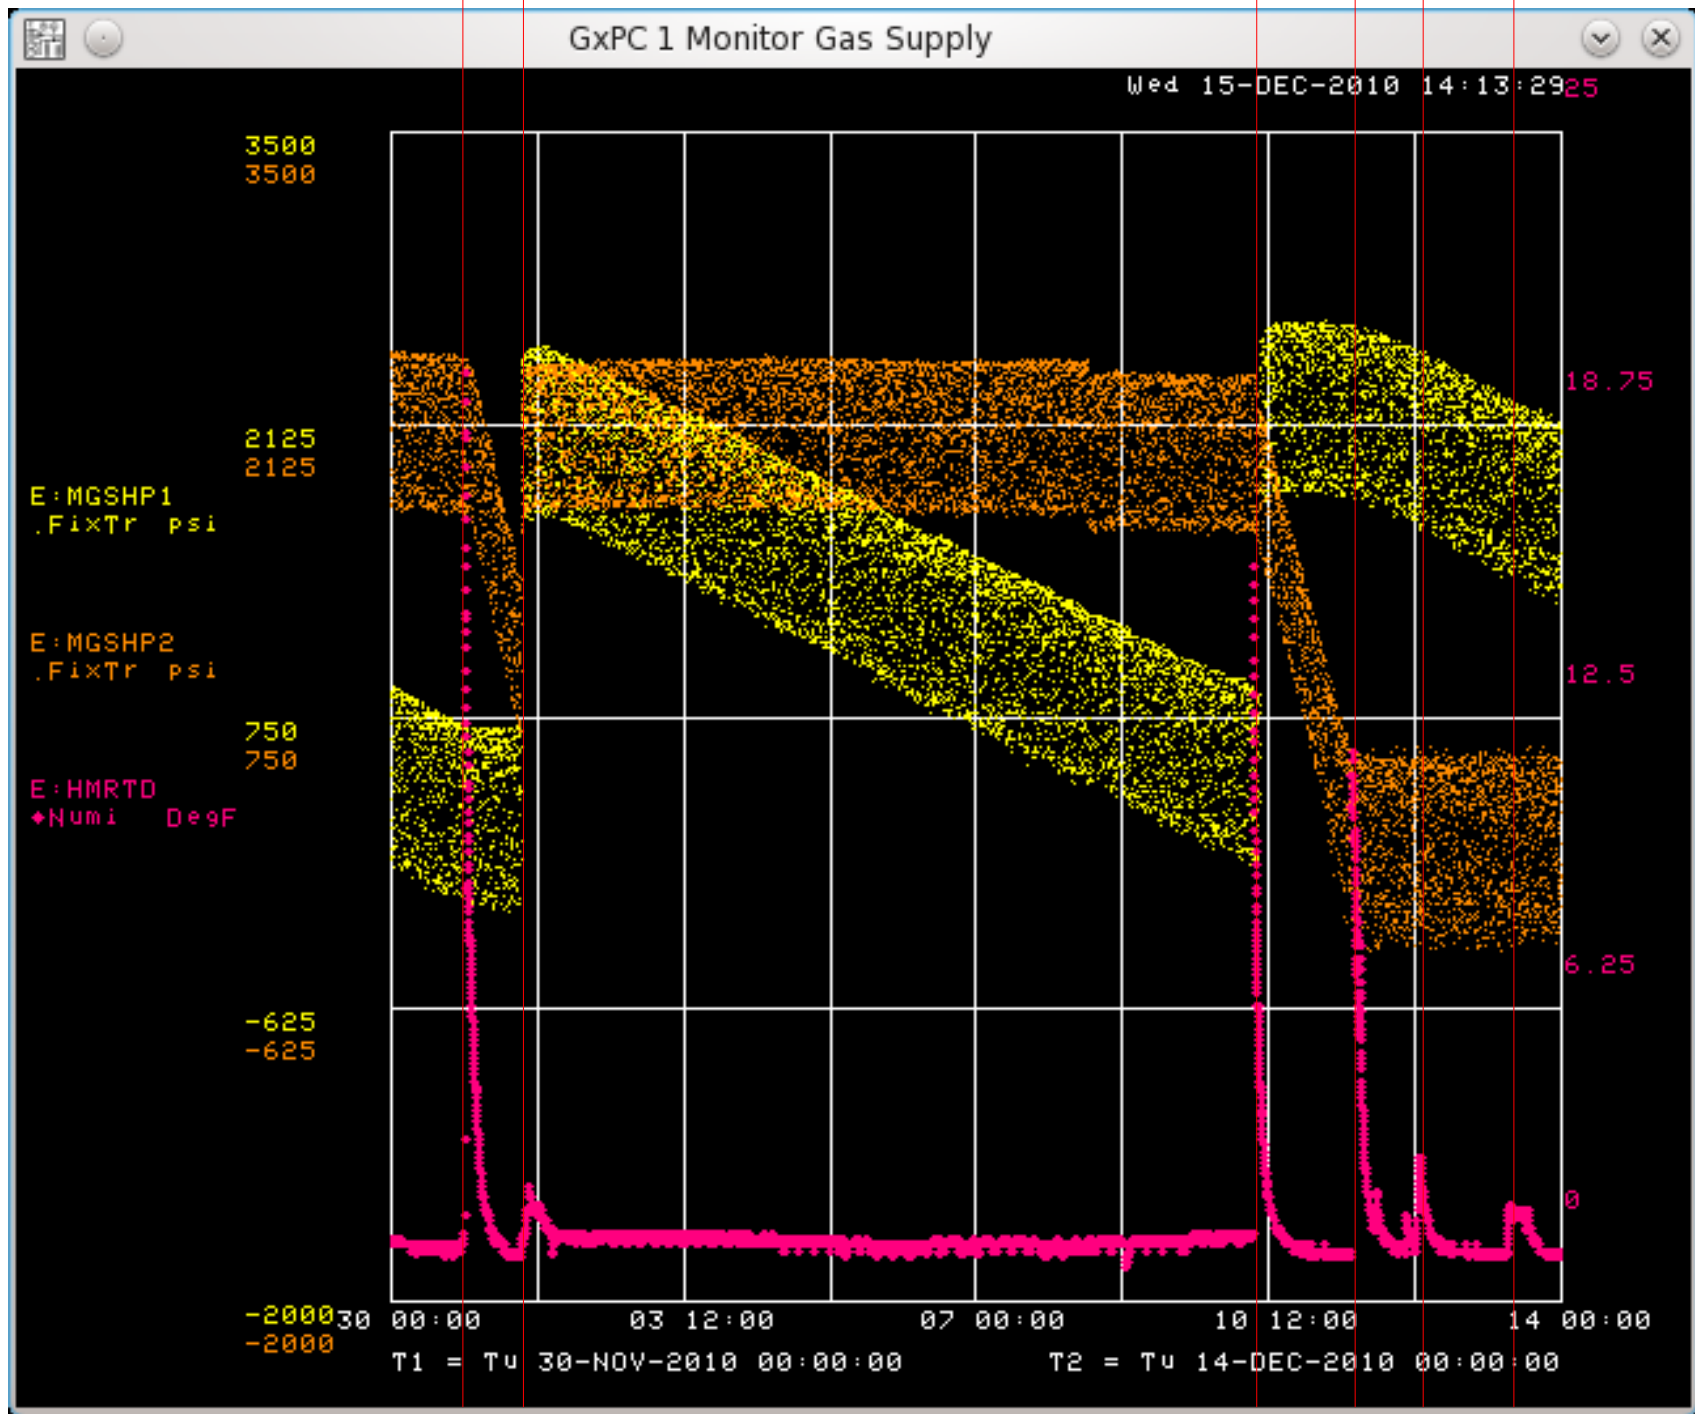
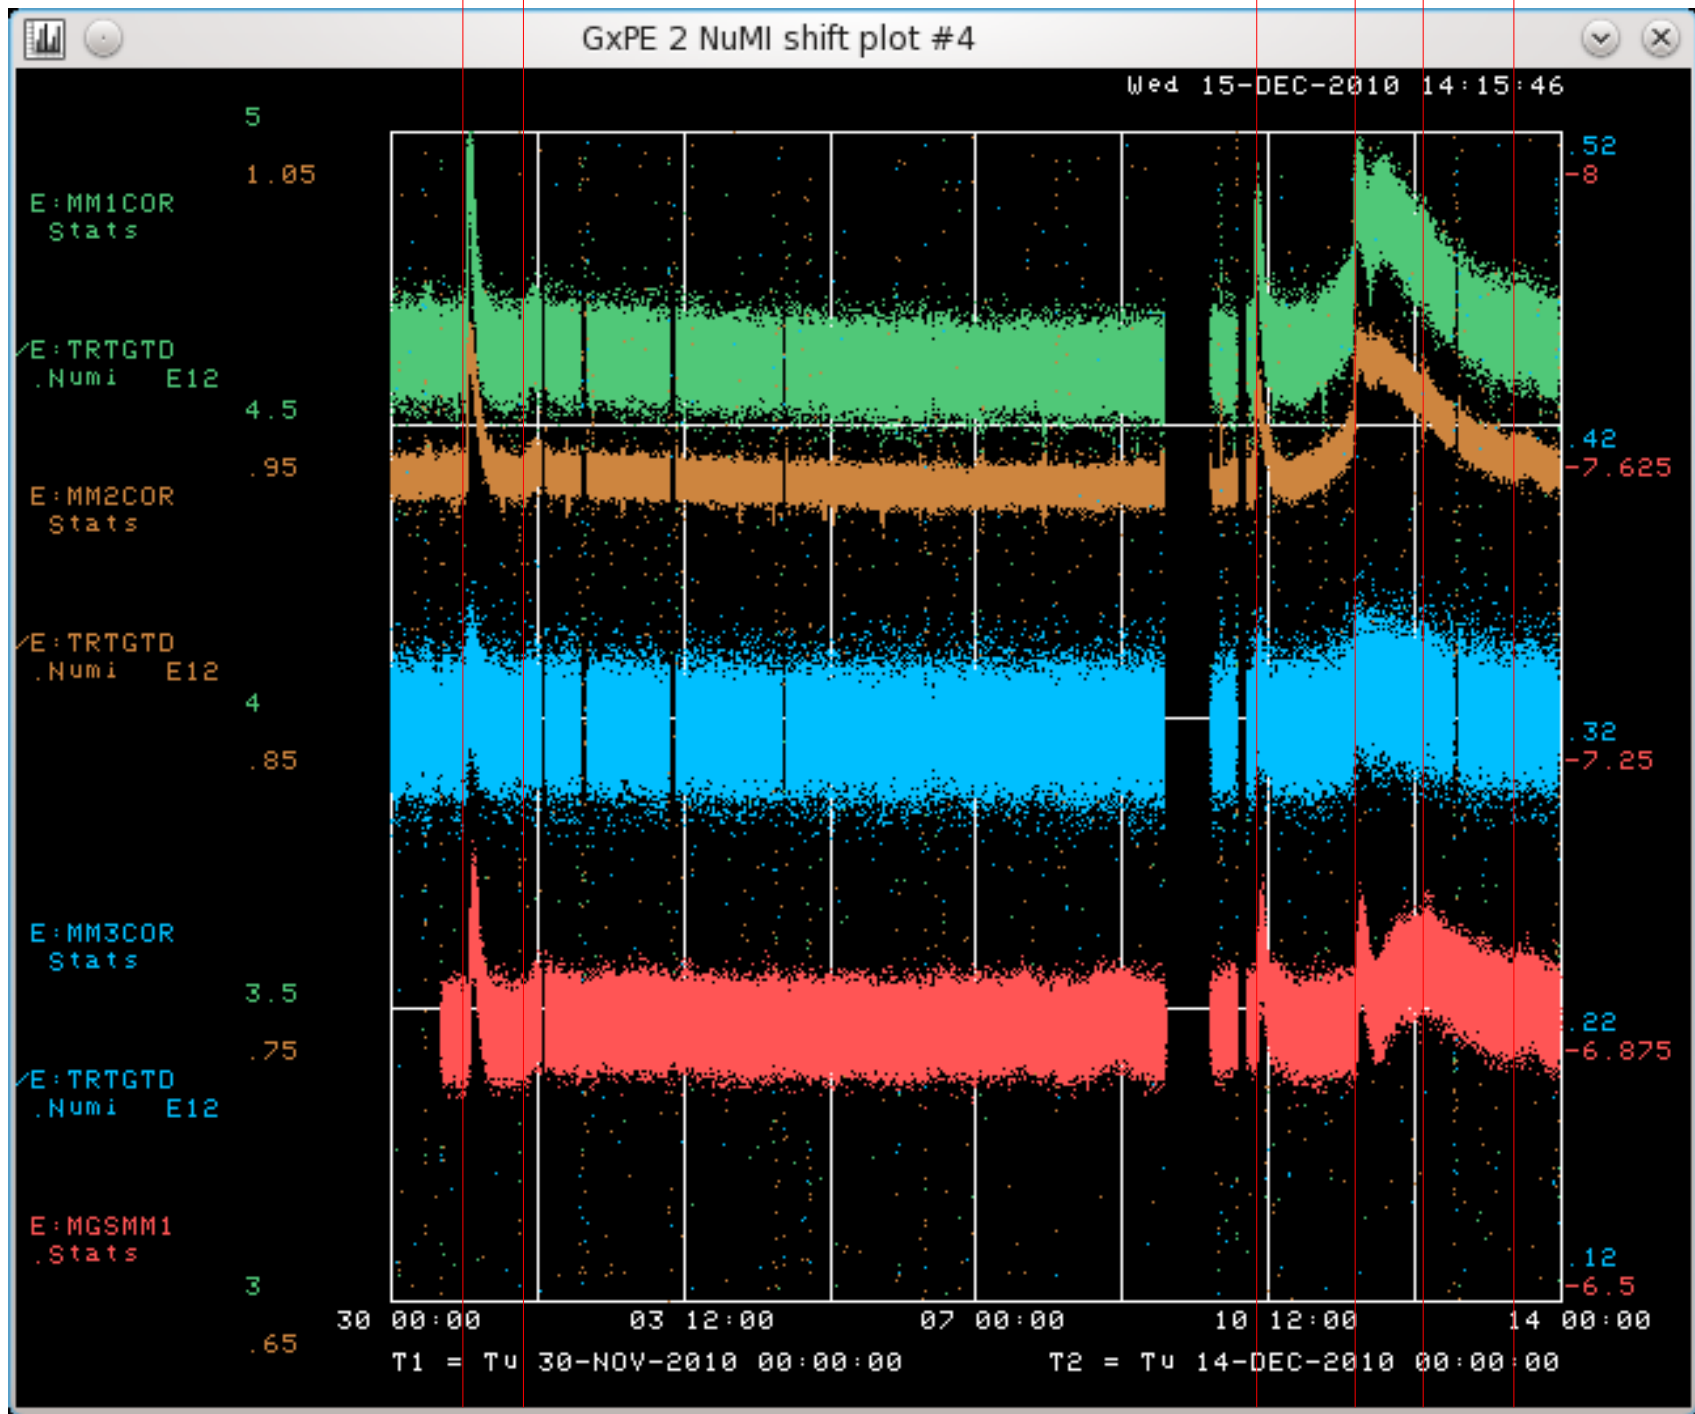
- The following plots shows “typical” gas contamination incidents which typically corresponds to gas cylinder exchanges.
- The beam is in LE010z-185i during the time shown (Nov 30- Dec 14 2010).

- The pages that follow describe the circumstances corresponding to each red numbered line shown on the plot.

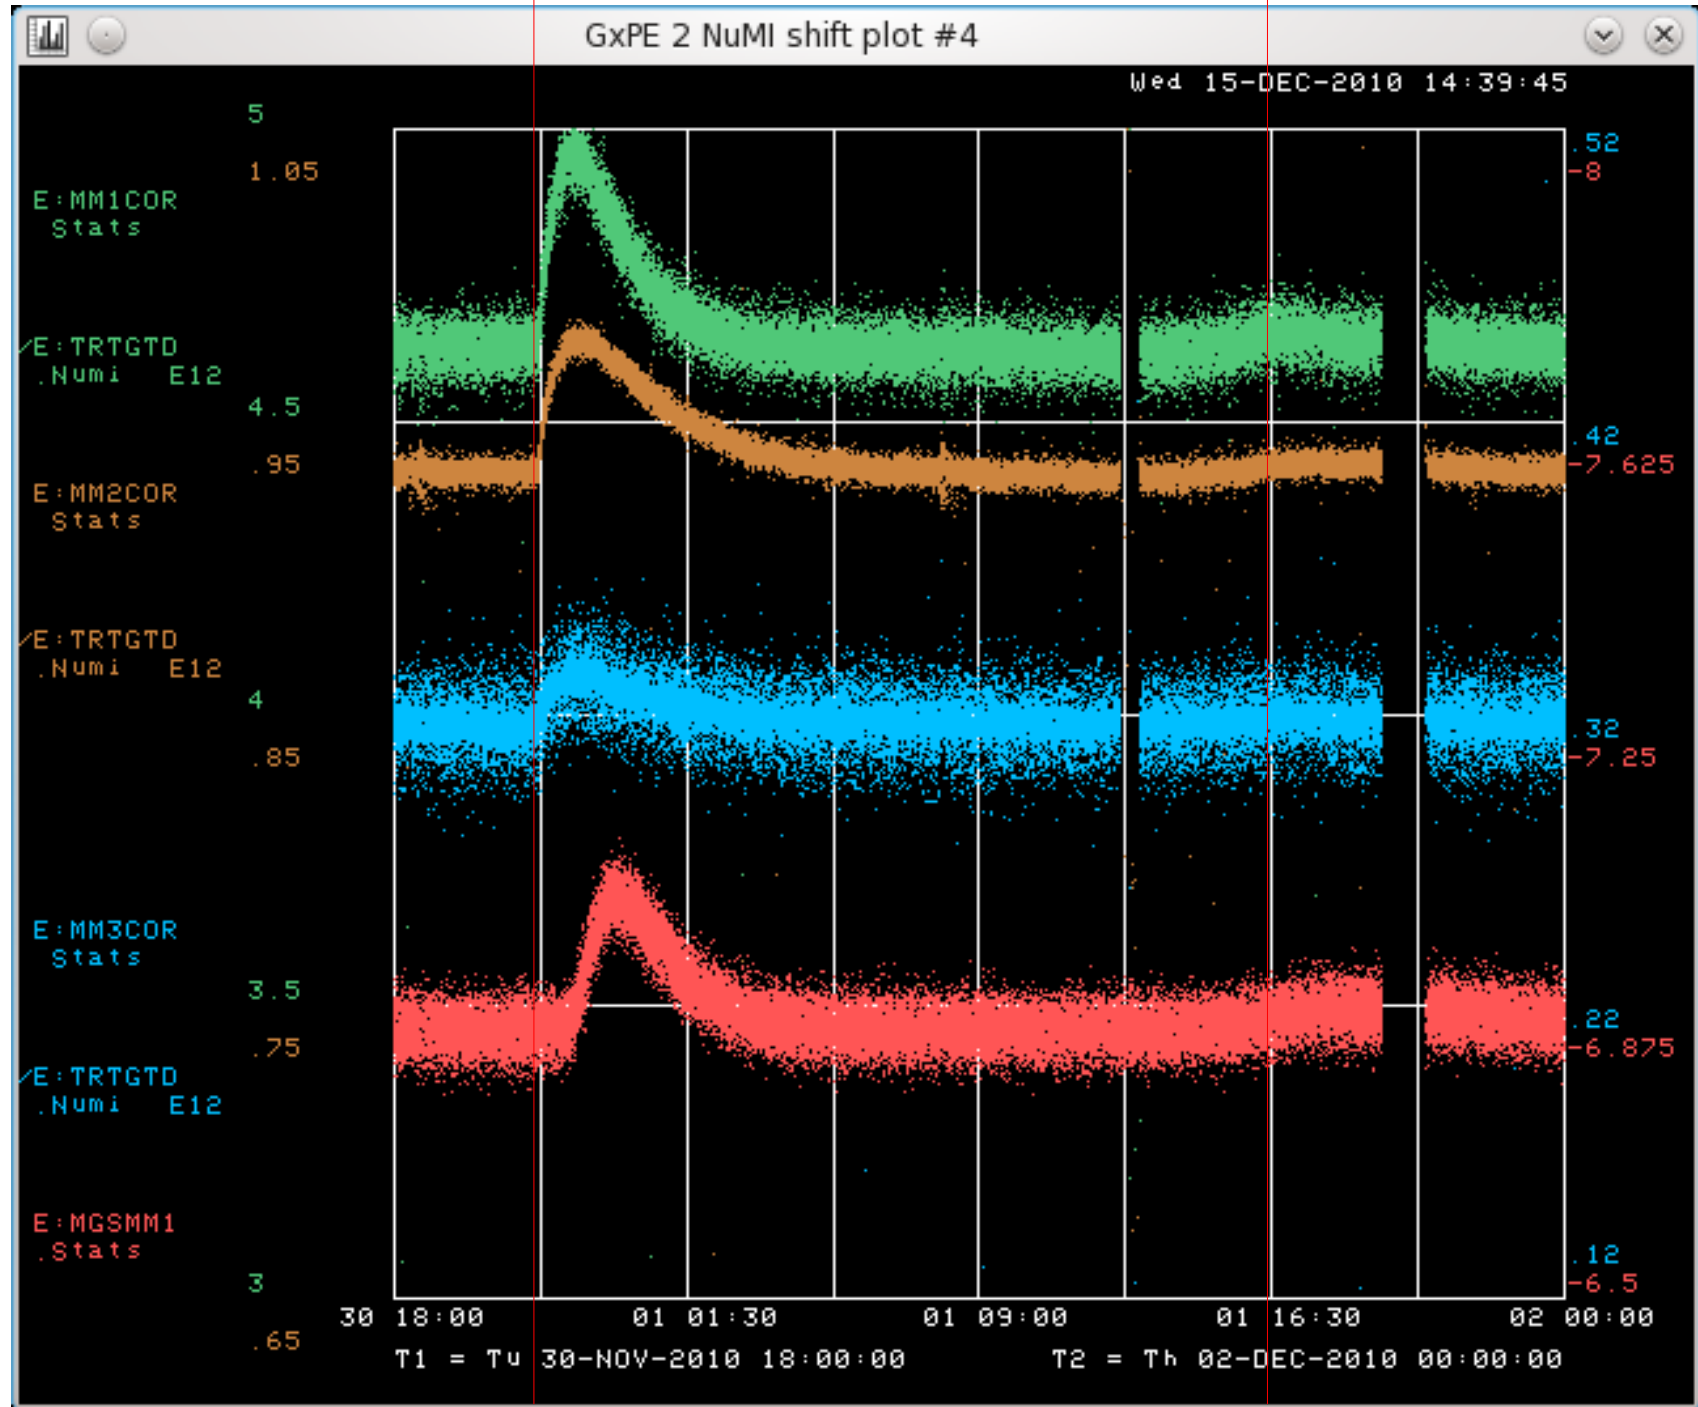
Time Zoom-in of plot on previous page

- Line 1: Prior to line 1 the system is drawing from the 8-bottle pack (indicated by E:MGSHP1 (yellow)). At line 1 the system automatically switches from drawing from the 8-pack (which is now empty) to drawing from the spare bottle (E:MGSPH2 (orange)). As is typical when a bottle exchange/automatic switch occurs there is gas contamination indicated by the jump in the Oxygen monitor (E:HMRTD) at the same time. The Muon Monitor signals and the Gas calibration monitor signal also jumps in response to the increase in O<sub>2</sub> level within the gas. Note that there is a short (~1/2 hour) delay in the jump in the muon monitor signals compared to the gas calibration chamber signal due to the fact that the gas calibration chamber is in the exhaust gas line of muon monitor 1, several hundred feet from from the mm1 itself. The signals start to decrease within a few hours as the contamination leaves the system.

- Line 2: All of the gas bottles are replaced with new, full, bottles. The system starts drawing from the 8-pack. The oxygen analyzer records a small jump in the impurity level. Upon very close inspection, the muon monitor signals also show a very small jump (most evident in mm1 signal) in response to the O<sub>2</sub> contamination but it is almost not noticeable.

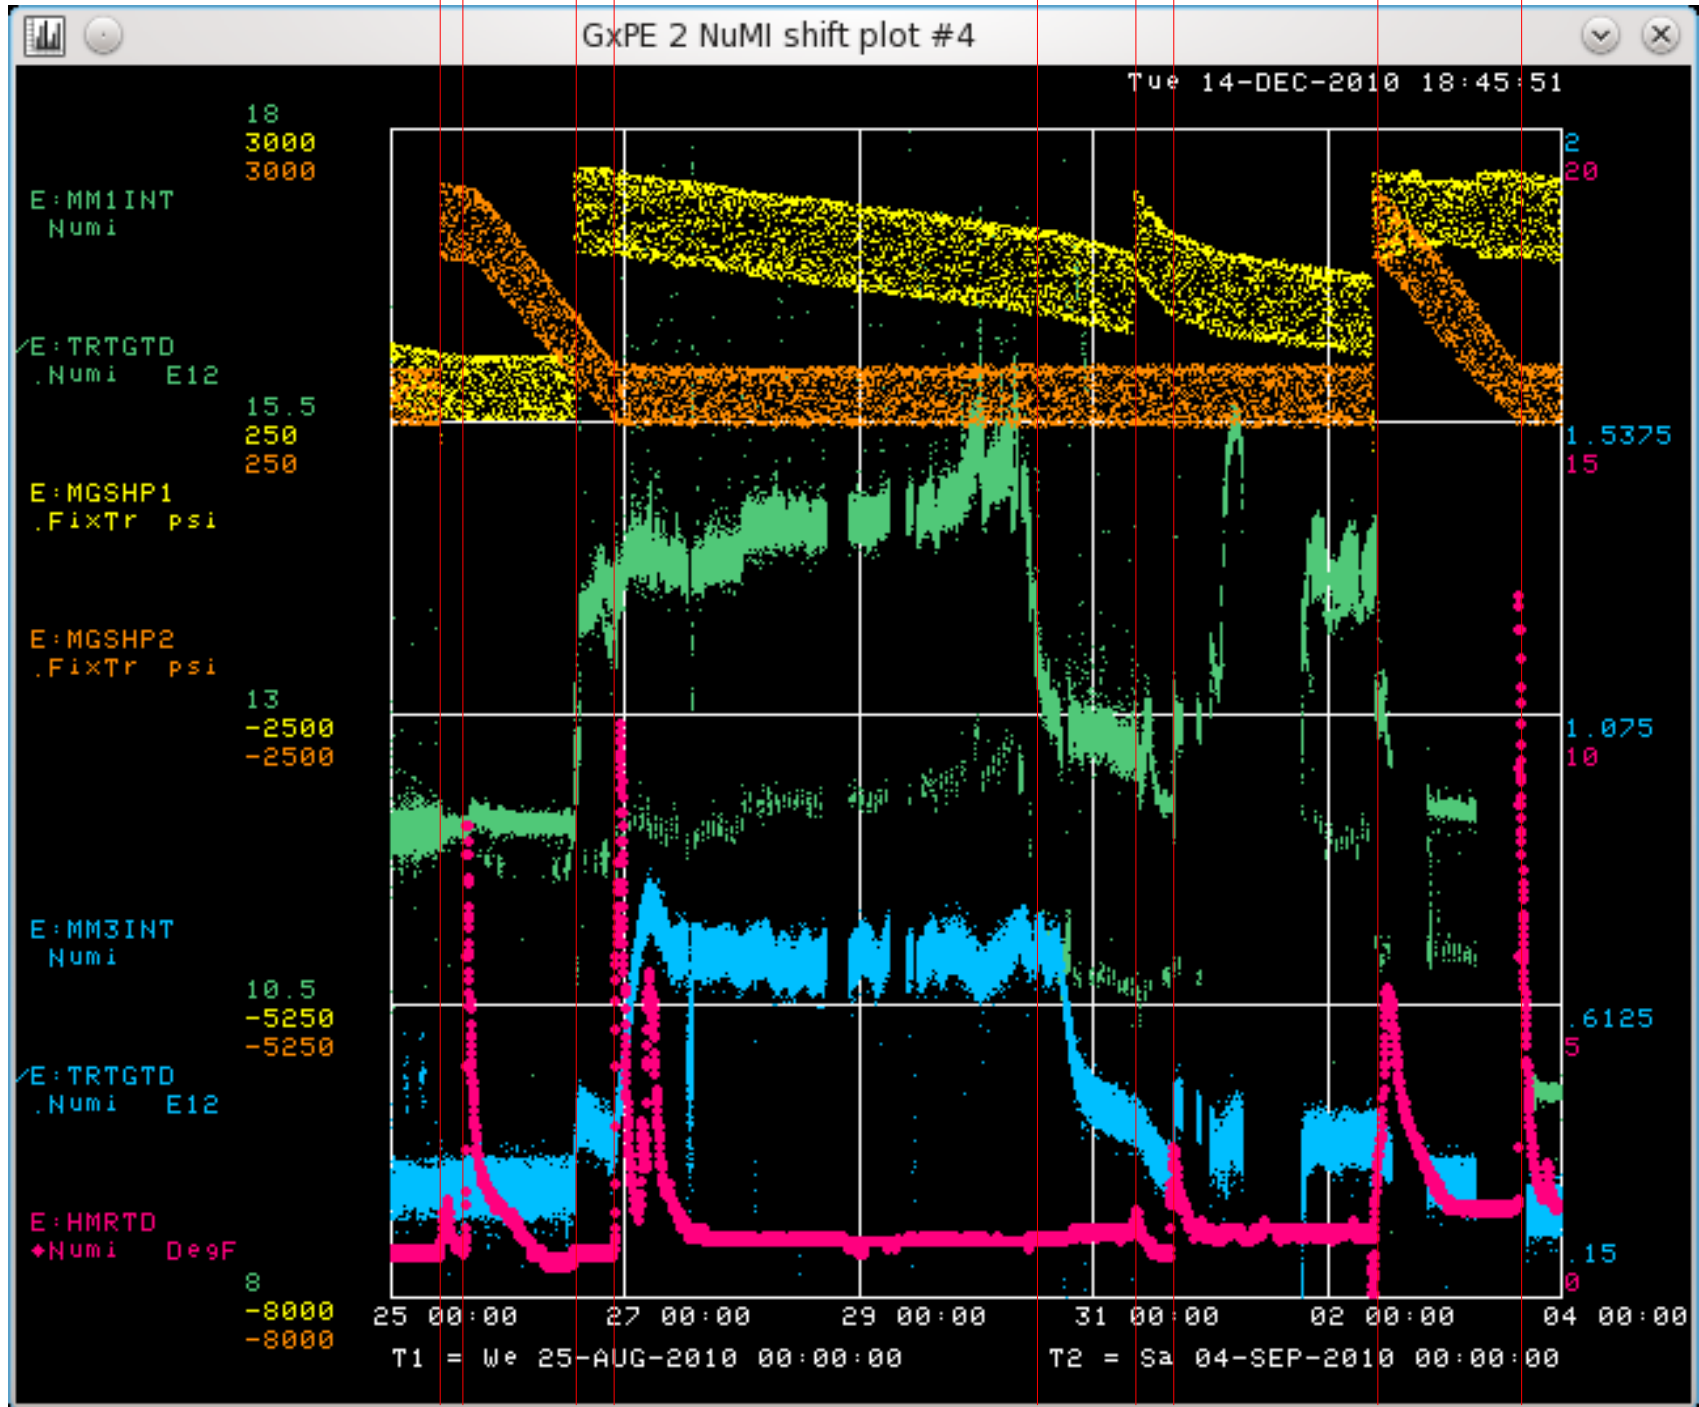
- The following plot is a particularly complicated instance of “bad” gas in the monitor system. The gas system uses a total of 9 “High Purity Grade” Helium commercial cylinders. In this instance some of the cylinders in the system were not in fact Helium but Nitrogen. In a previous incident there was an Argon cylinder placed in the system.

- Line 1: Both the spare bottle and the 8-pack are almost empty and require exchange. The Spare bottle only is exchanged. This is probably because there were not enough helium cylinders to replace all 8 bottles in the 8 pack. The system continues drawing from the 8-pack. The oxygen analyzer records a small jump in the impurity level

- Line 2: The system switches from drawing from the 8 pack to the spare bottle. The oxygen analyzer records a small jump in the impurity level. The muon monitor signals also shown a jump in response to the O2 contamination but on the scale of the plot it is not noticeable.

- Line 3: The 8-pack is replaced, but the system is still drawing from the spare bottle as is evident from the continued drop in the E:MGSHP2 reading after line 3. However at this same time the monitor signals experience a large jump. This jump is consistent with (looks like) gas contamination but the O2 monitor does not indicate O2 contamination. However the O2 monitor will only respond to O2 levels not other gases like Nitrogen, which is the largest component of Air.

- Line 4: The system switches from drawing from the spare bottle to the 8-pack. A large jump in the O2 impurity level is recorded by the O2 monitor. Muon monitor 3 signal experiences a very large jump. A short time later the O2 monitor records a few other jumps in the O2 level probably because at those instances other bottles within the 8-pack a starting to contribute to the system\*. From my experience, three things indicate that this is not just a case of O2 contamination:

1. The size of the jump in the signals (~70% jump in MM3).
2. The severe non-linearity in MM1 signal.
3. The signals do not begin to drop within a few hours.

Subsequent inspection of the gas cylinders showed that one of the bottles was Nitrogen not Helium.

- Line 5: The beam intensity drops. Because MM1 is experiencing severe non-linearity the signal drops significantly in response to the decrease in beam intensity. Shortly thereafter the Nitrogen bottle is valved off from the system. Thus the drop in MM3 signal a few hours later.

- Line 6: The Nitrogen bottle is replaced with helium. The signals drop faster.
- Line 7: There is a jump in the O<sub>2</sub> level and the monitor signals jump up and remain there. Most likely this is what happened: The new helium bottle was at the highest pressure of all of the bottles so between lines 6-7 it was supplying the system alone\*. At line 7 that bottle reaches the same pressure as the other 7 bottles and so all of the bottles start to contribute gas to the system. The fact that at this time the signal jumps up seems to suggest that there is some sort of contamination (another one of the bottles is nitrogen, or the purity of one of the helium bottles is not “high purity grade”) in one or more of the other 7 bottles. More than this, there is no definite explanation.

- Line 9: The spare bottle is used up and the system automatically switches to the 8-pack. The O<sub>2</sub> monitor jumps. Unfortunately at the exact instant this happens the beam is off. When the beam returns the beam is now in LE100z-200i, prior to line 9 it was in LE100z-200i. The muon monitor signals are changed due to the change in beam configuration so after line 9 cannot be compared to before line 9. Now one can only monitor the signals to make sure that they are stable (i.e. Flat, no jumps). For the time after line 9 (not shown), the signals are stable indicating the gas problem has been remedied.

- Line 8: Due to the fact that the signals are still not back to “normal”, I schedule a gas bottle exchange of all of the bottles in the system. This occurs at line 8. The system starts drawing from the newly replaced spare bottle.
